Chichester City LCWIP

Appendix C

Walking audit – Core Walking Zone & key routes

June 2020

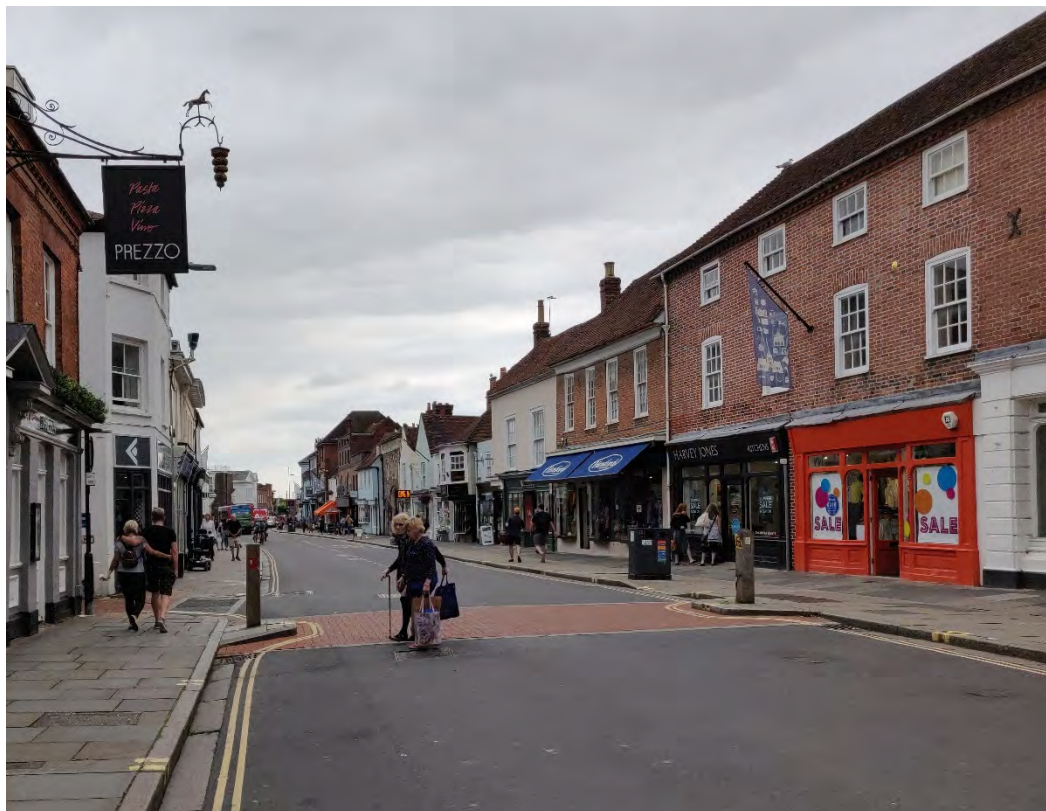
Example of Poor crossing provision (subcategory 12), South Street

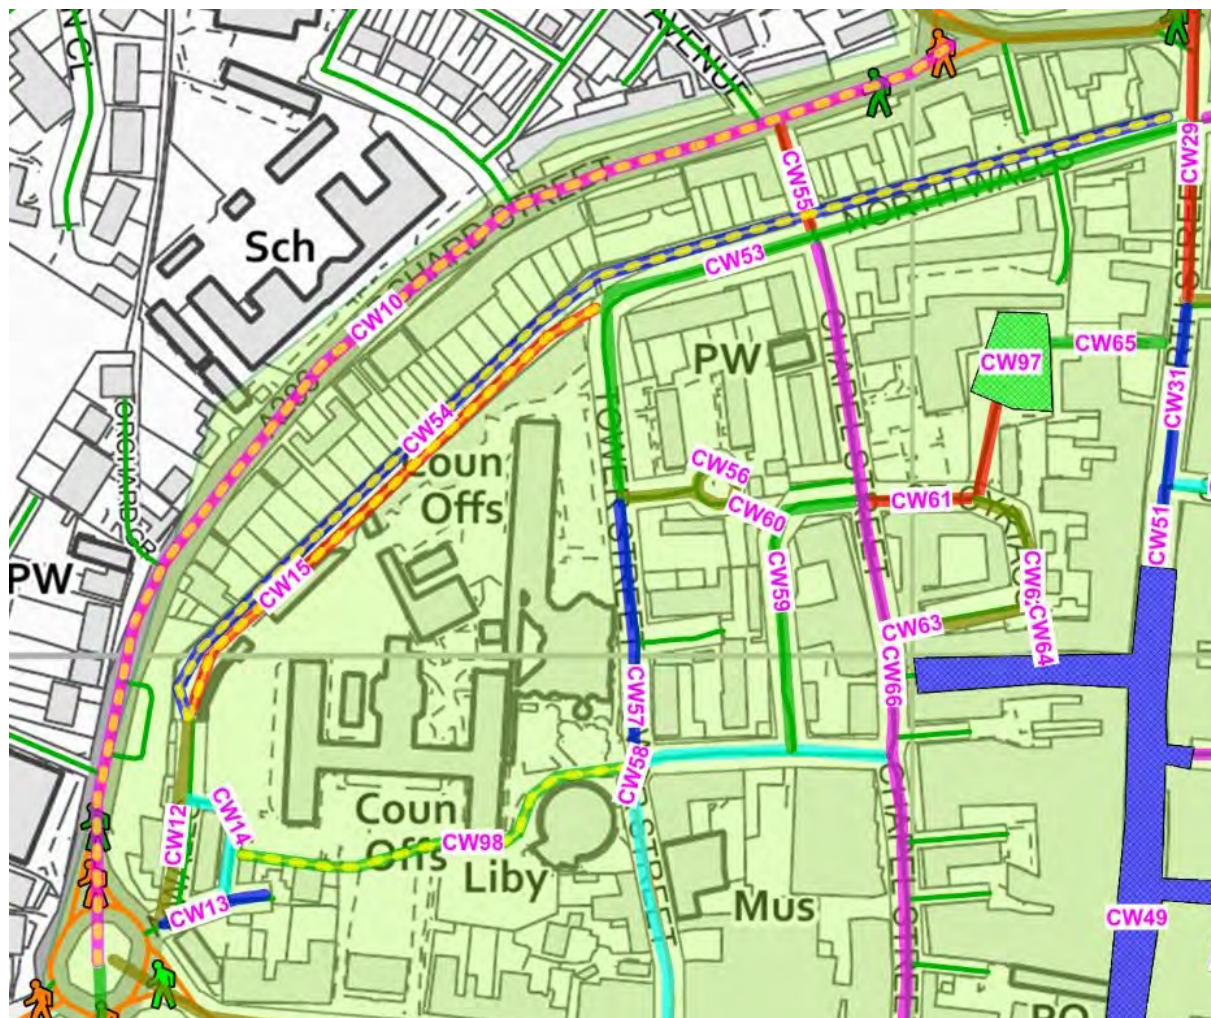
Plan 5. North west area

- **CW10** Orchard Street, which failed on traffic noise and pollution.
- **CW15** North Walls shared cycle/footpath and **CW54** North Walls footpath, both of which failed on the fear of crime category due to their isolated nature. This could be a deterrent to people walking and cycling, particularly after dark.

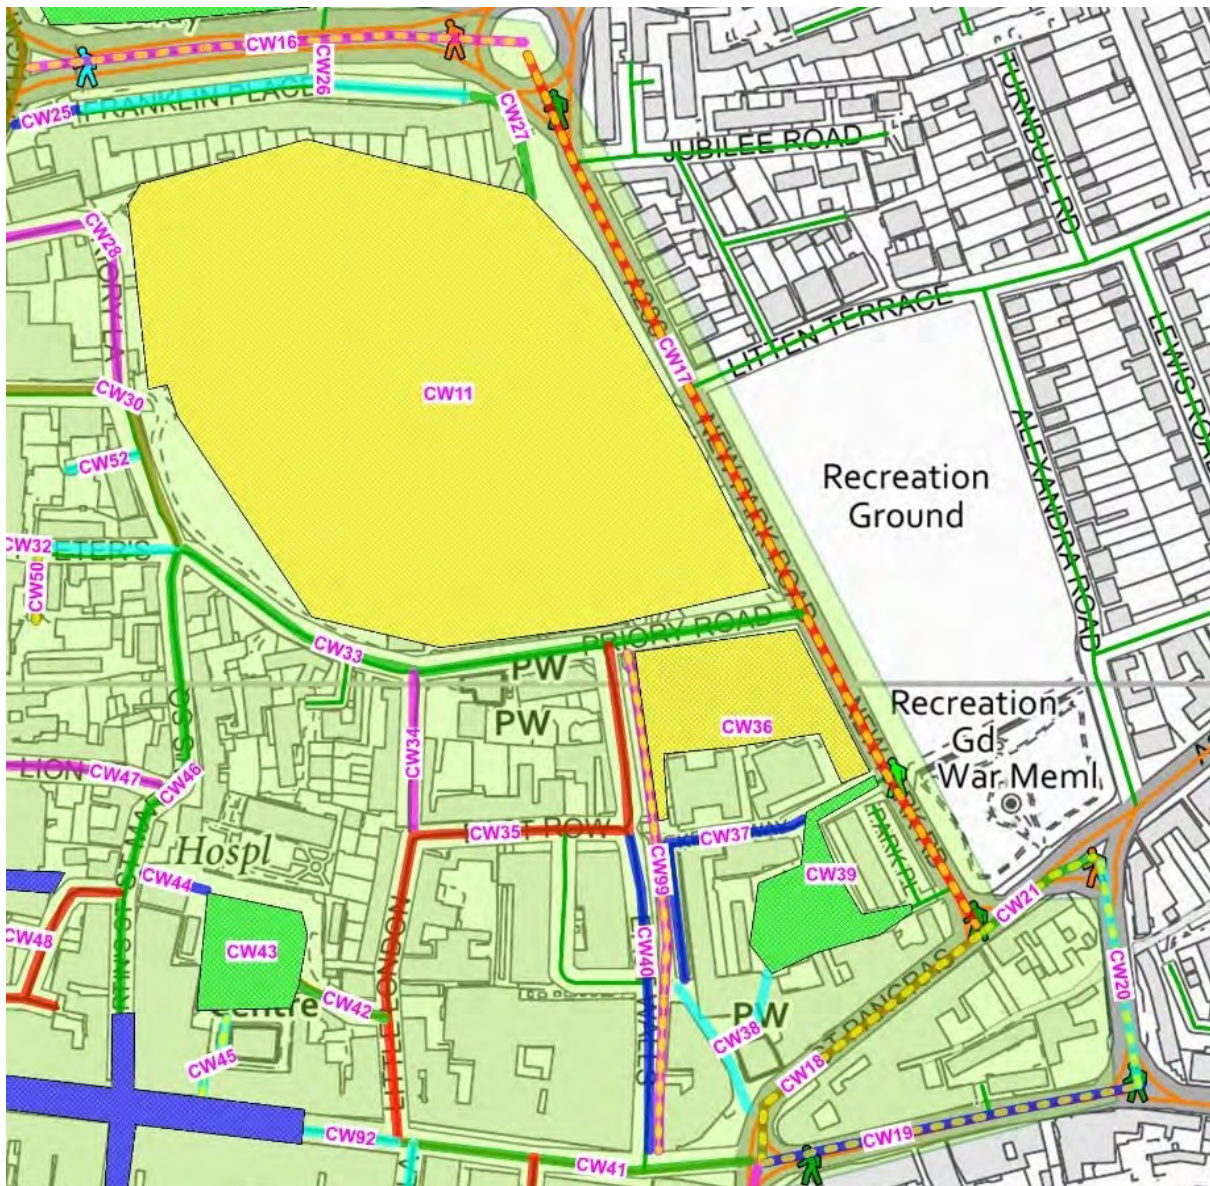
Plan 6. North East area

- **CW16** Oaklands Way failed on maintenance as parts of the narrow footpath on the south side is significantly overgrown by adjacent bushes.
- **CW17** New Park Road, **CW18 & CW21** St Pancras, **CW19** The Hornet and **CW20** Needlemakers all failed on traffic noise and pollution.
- **CW11** Priory Park, **CW36** New Park open space and Keats Way and **CW99** Upper Walls Walk failed on fear of crime, again due to their isolated nature.

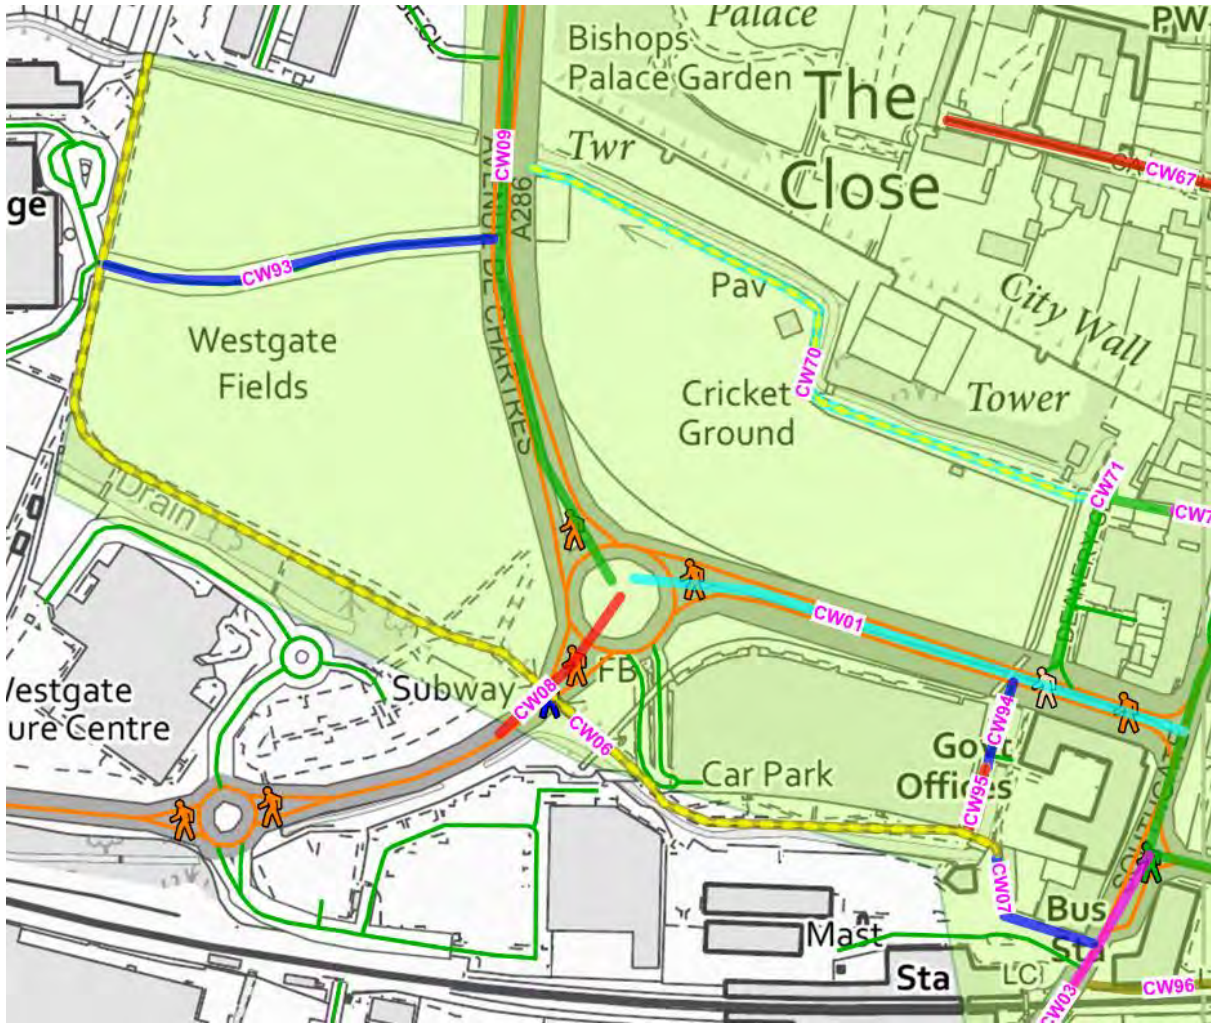
Plan 7. South area

- **CW06** Chichester Station - Chichester College path and **CW70** Walls Walk by River Lavant, both of which failed on the fear of crime category due to their isolated nature.

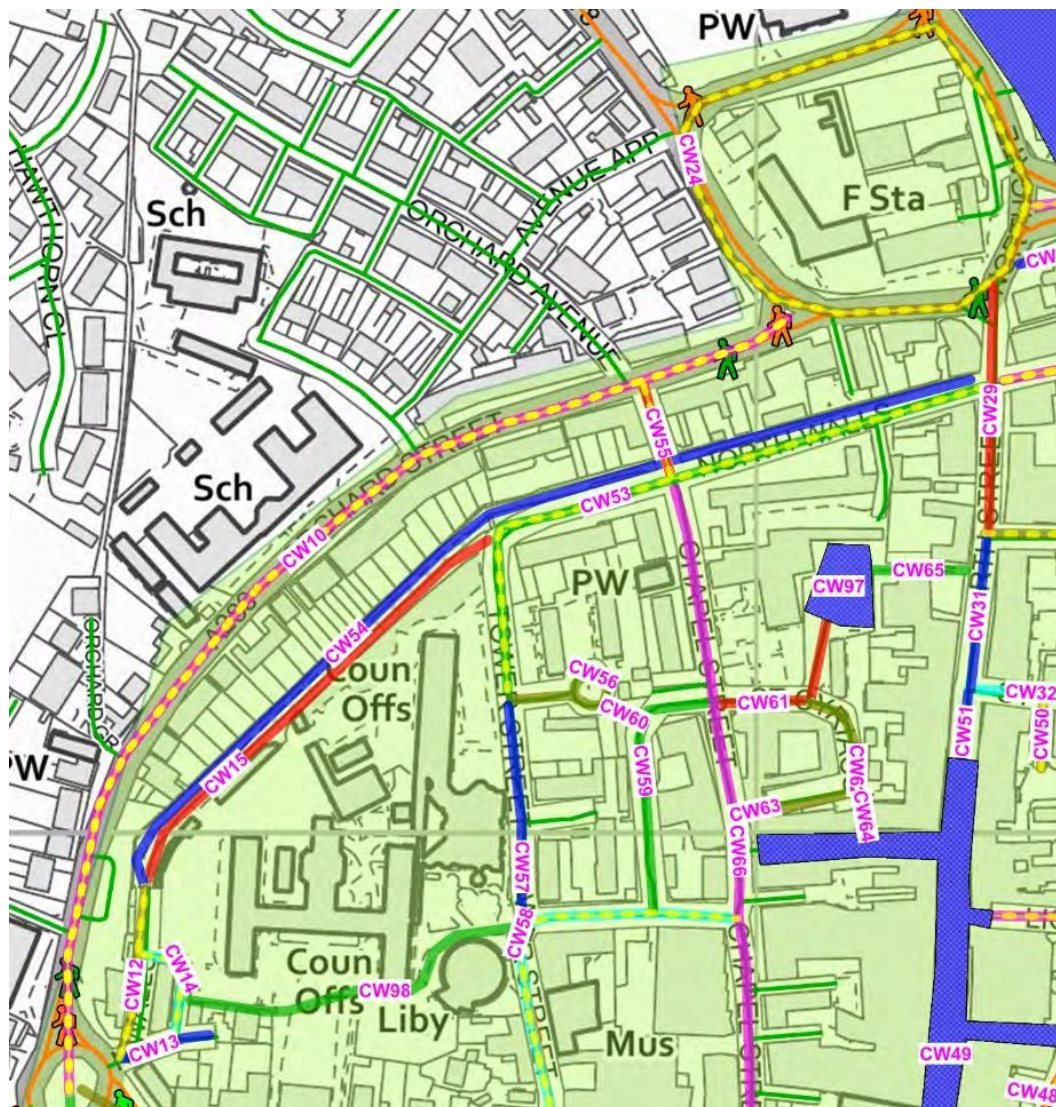
Plan 8. North west area

- **CW10** Orchard Street has narrow pavements, areas of poor surfacing and a narrow island by the roundabout at its southern end.
- **CW24** Northgate gyratory, also has sections of narrow pavement which is poor for such a major feature.
- **CW12** and **CW53** (both North Walls) and **CW58** Tower Street & The Woolstaplers also have narrow pavements.

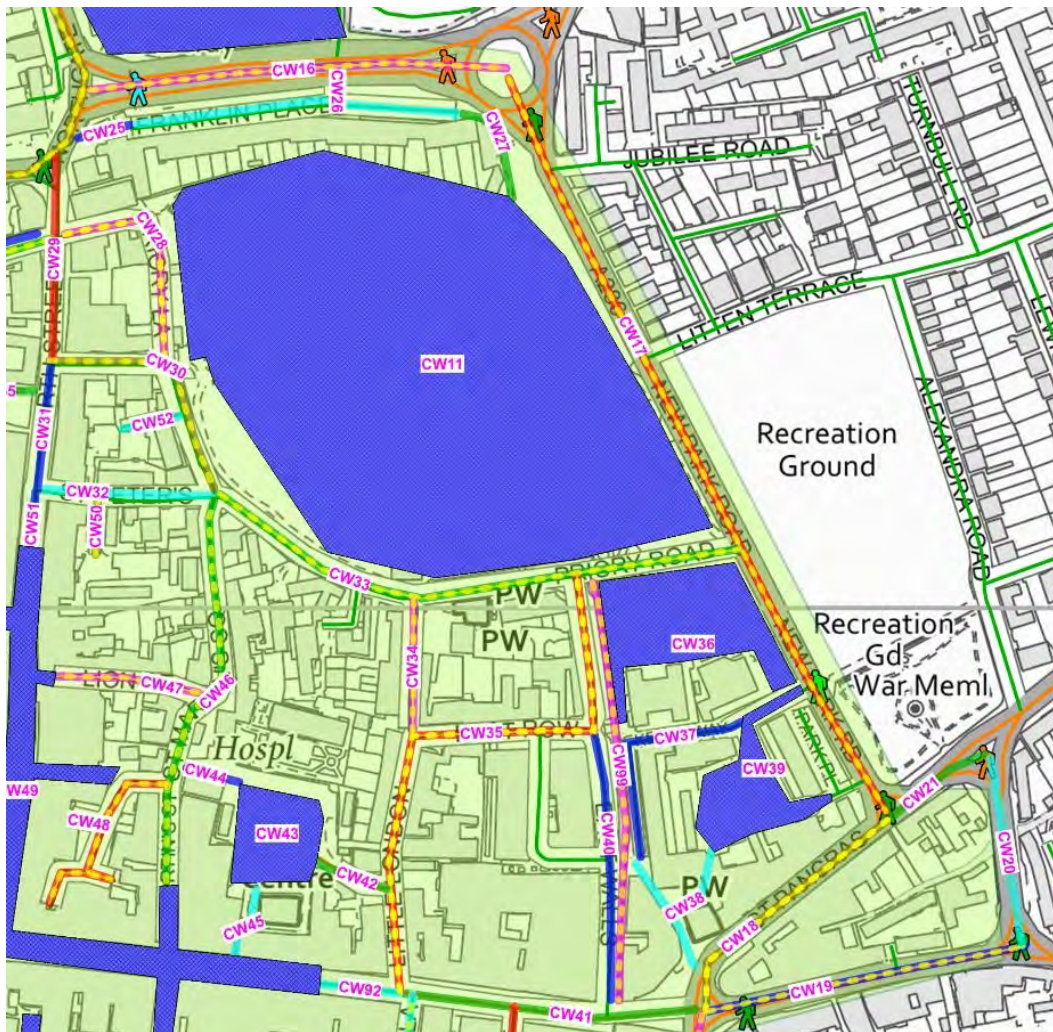
Plan 9. North east area

- **CW16** Oaklands Way, **CW17** New Park Road, **CW19** The Hornet, **CW33** Priory Road, **CW34** Little London, **CW47** Lion Street and **CW52** Jays Walk all have narrow pavements.
- **CW18** St Pancras and **CW28** Priory Lane have narrow pavements and issues with poor surface quality.
- **CW30** Guildhall & Priory Road have issues with crossing points.
- **CW35** Little London and East Row and **CW46** St Martin's Street have bollards and parking meters obstructing and reducing already narrow pavement widths. Little London also has a redundant guardrail panel restricting it further.
- The north end of **CW99** Upper Walls Walk can only be accessed via steps.

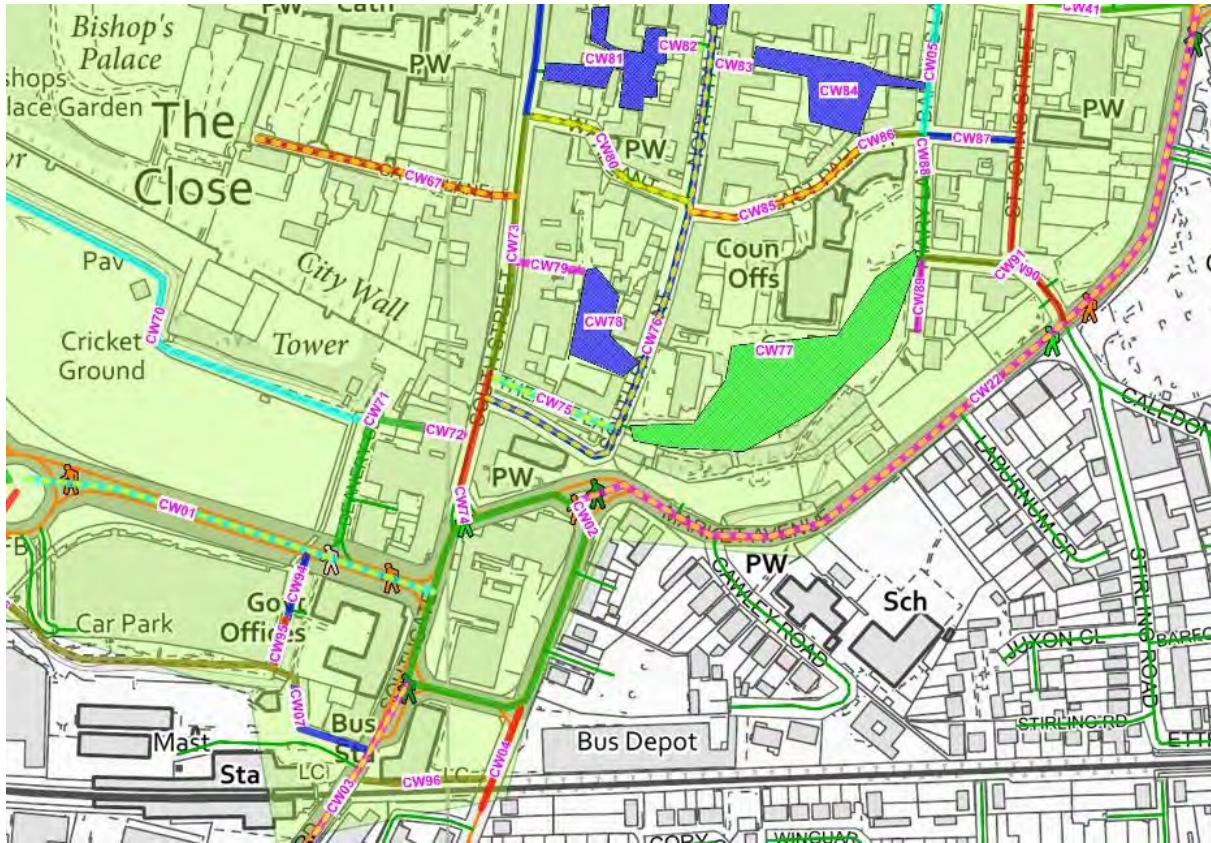
Plan 10. South area

- **CW03** Southgate & Stockbridge Road, **CW75** Theatre Lane, **CW76** North and South Pallant, **CW80** West Pallant and **CW85** East Pallant all have narrow pavements.
- **CW01** Avenue de Chartres and **CW22** Market Road both have narrow crossings.
- **CW67** Canon Lane has a very poor pavement surfacing, and in particular the pavement on the north side is very narrow.

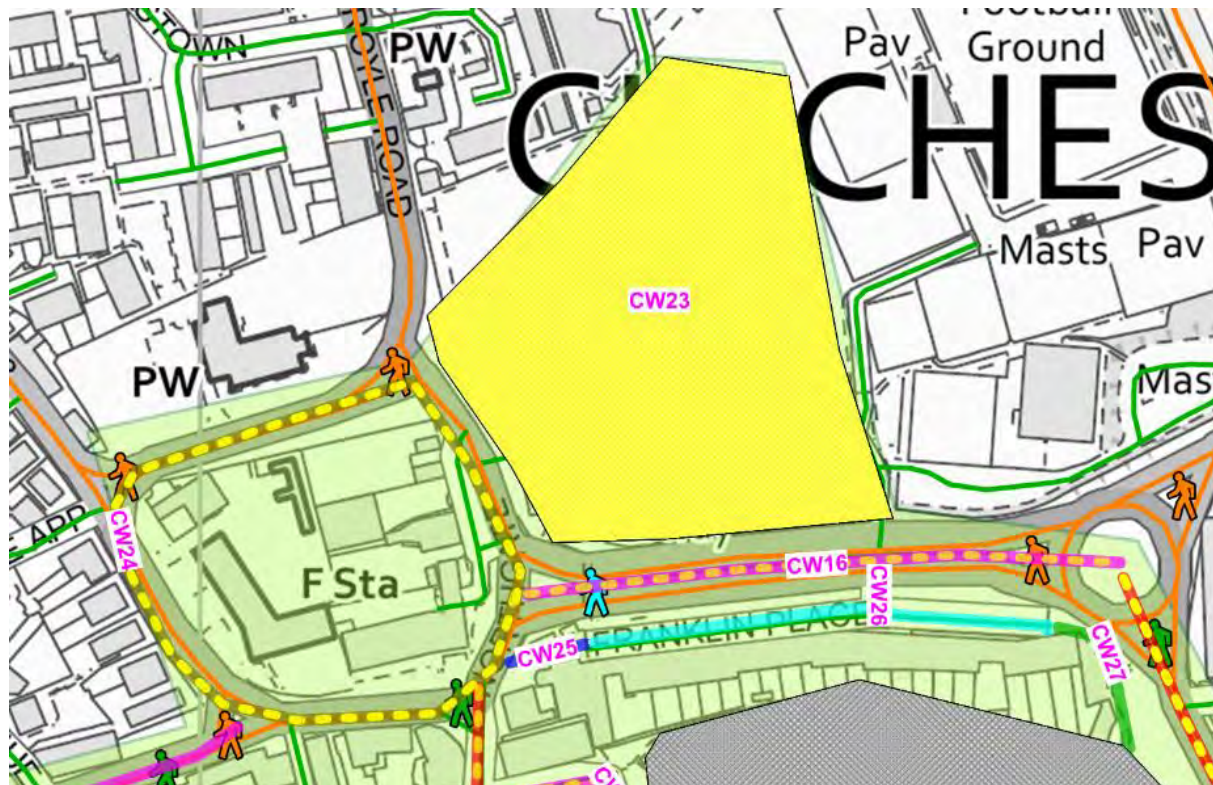
Plan 11. North area

- **CW16** Oaklands Way has a central reservation which means there are no places to cross informally along its length.
- **CW23** Northgate car park has very poor provision for pedestrians (including drivers and passengers walking to or from their cars), with no footpath provision whatsoever. There are pedestrian signs but these direct people along and across the car park roadways.
- **CW24** Northgate gyratory is missing crossings on key desire lines.

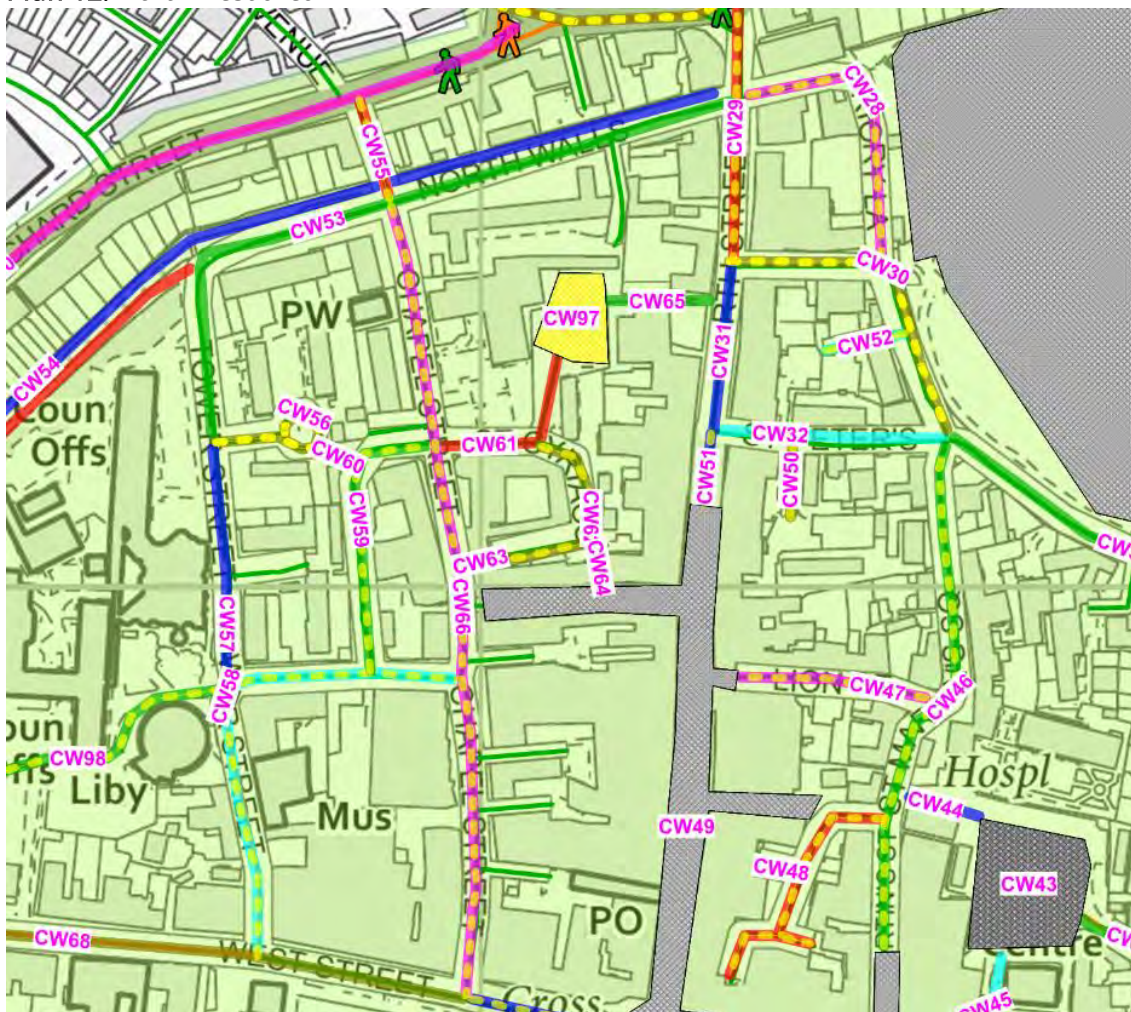
Plan 12. North west area

- **CW28** Priory Lane, **CW52** Jays Walk, **CW55** Orchard Street, **CW62** St Cyriacs, **CW97** St Cyriacs car park and **CW98** West Sussex County Council campus all lack a pavement or other walking provision on key pedestrian desire lines.
- **CW29** North Street, **CW46** St Martin's Street, **CW47** Lion Street, **CW51** North Street, **CW58** Tower Street & the Woolstaplers, **CW59** The Providence, **CW60** Path between Tower Close and The Providence and **CW66** Chapel Street all lack crossings on key pedestrian desire lines.
- **CW30** Guildhall Street & Priory Road and **CW56** Tower Close both have missing pavements and crossings on key pedestrian desire lines.

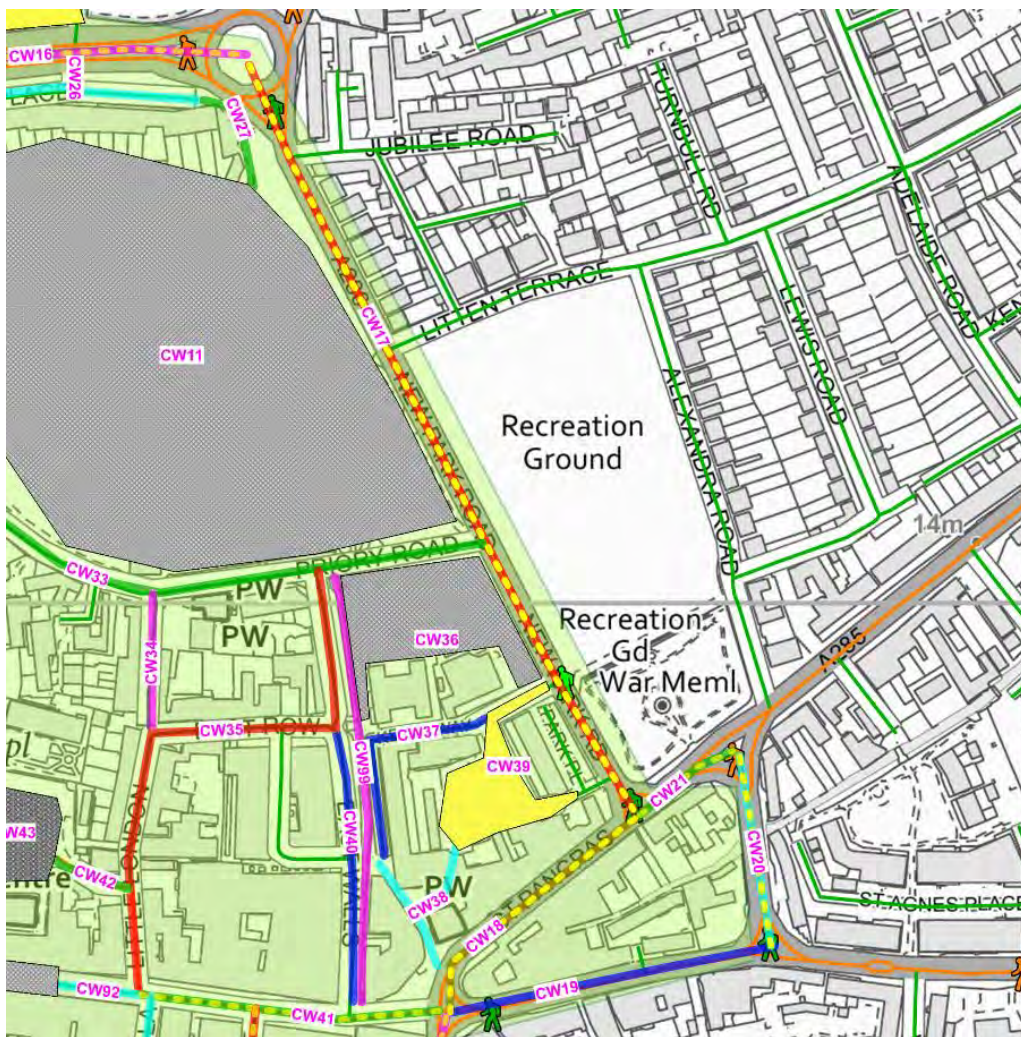
Plan 13. North east area

- **CW17** New Park Road which suffers from lack of continuous pavement provision, crossings on desire lines, gaps in traffic in peak periods and staggered nature of existing crossing points.
- **CW18** St Pancras is also missing crossings on key desire lines and with staggered delay of exiting crossing provision.
- **CW20** Needlemakers has poor crossing location and heavy traffic at peak hours reducing crossing gaps.
- **CW21** St Pancras and **CW41** East Street both lack crossings on key desire lines.

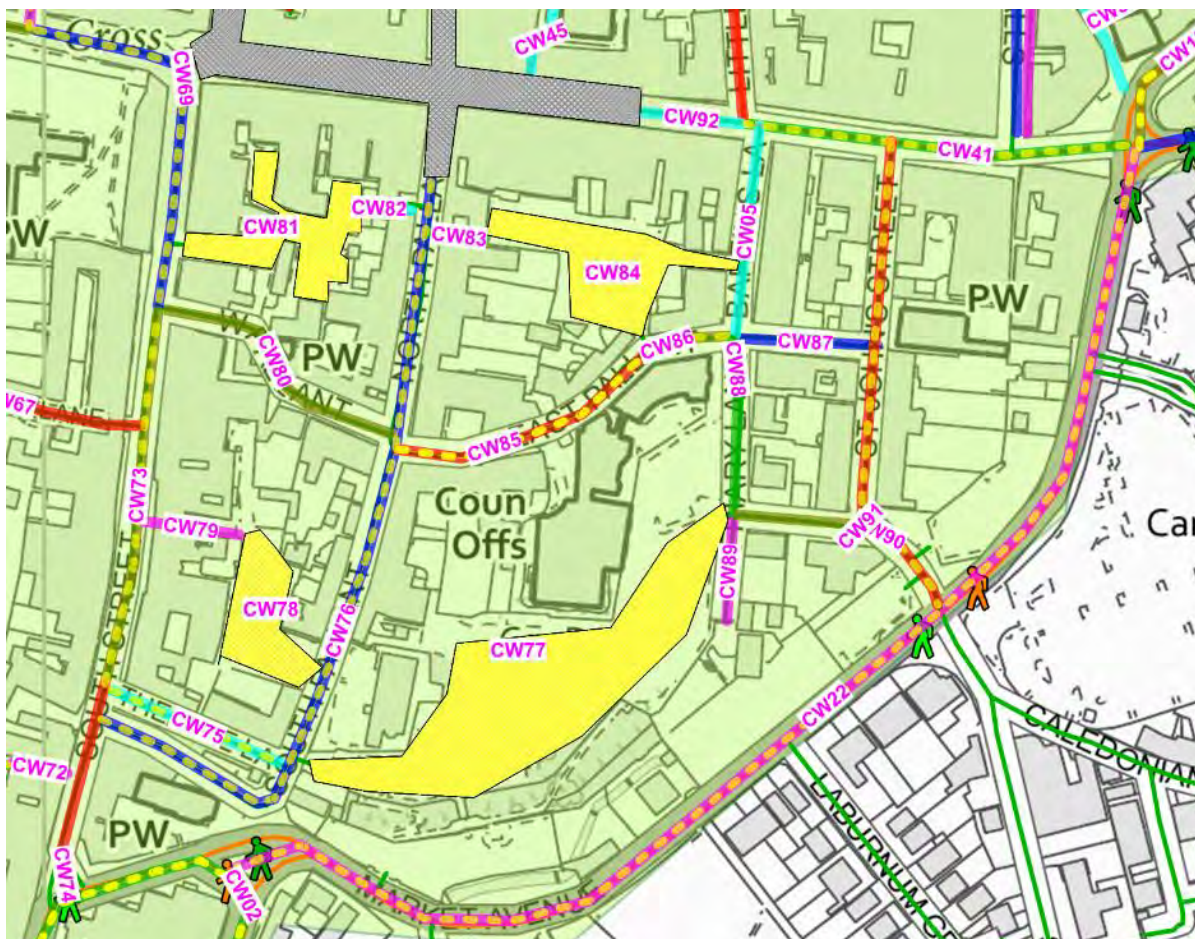
Plan 14. South east area

- **CW76** North & South Pallant and **CW78** South Pallant car park both have no footpaths or other walking provision on pedestrian desire lines.
- **CW77** Cawley Priory & East Pallant car parks, **CW81** Cooper Street car park, **CW84** Baffins Lane car park and **CW85** East Pallant all lack direct pavement provision and crossings on desire lines.
- **CW22** Market Road, **CW69** West & South Streets, **CW73** South Street, **CW75** Theatre Lane, **CW86** East Pallant and **CW90** St John's Street are all missing crossings on key pedestrian desire lines.

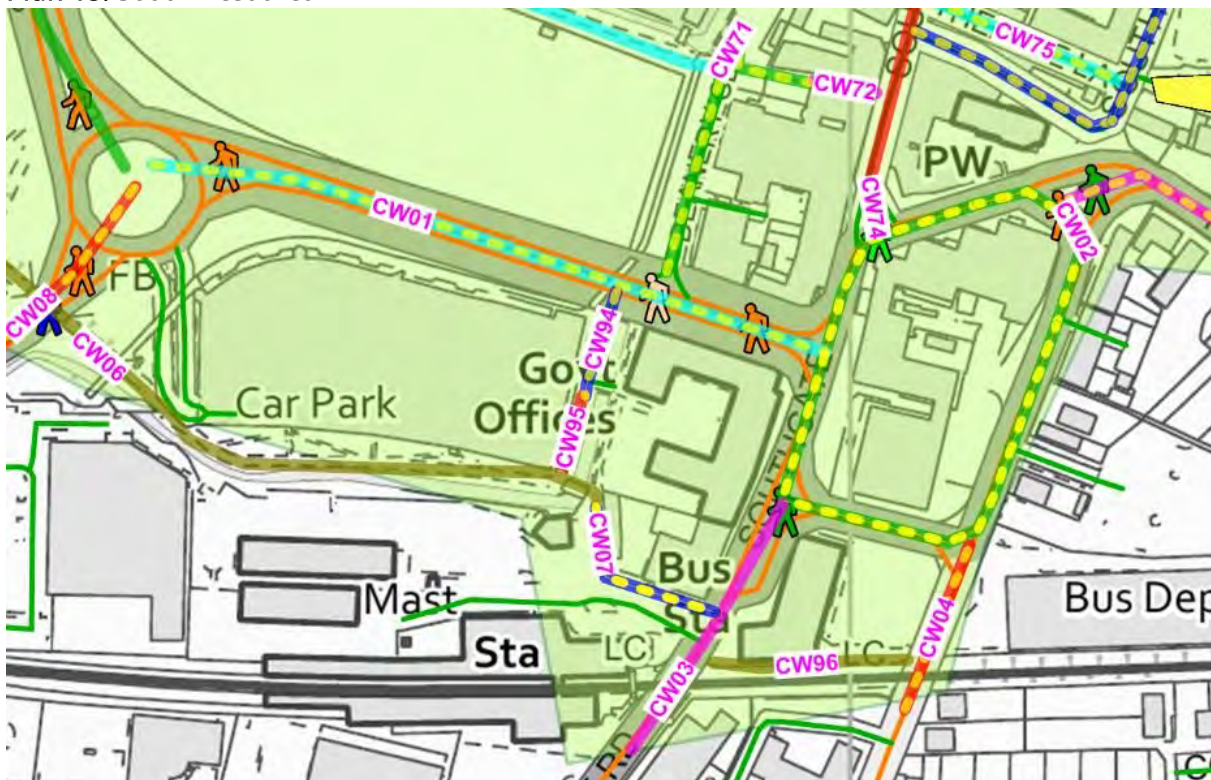
Plan 15. South west area

- **CW08** Via Ravenna is missing pavement provision.
- **CW02** Southgate gyratory is missing continuous pavement provision and the staggered nature of existing crossings adds delay.
- **CW07** Station Access lacks continuous pavement provision, crossings on desire lines and staggered crossings adding to delay.
- **CW04** Basin Road and **CW71** Deanery Close lack crossings on pedestrian desire lines.
- **CW01** Avenue de Chartres lacks gaps in traffic during peak hours making it difficult to cross safely.

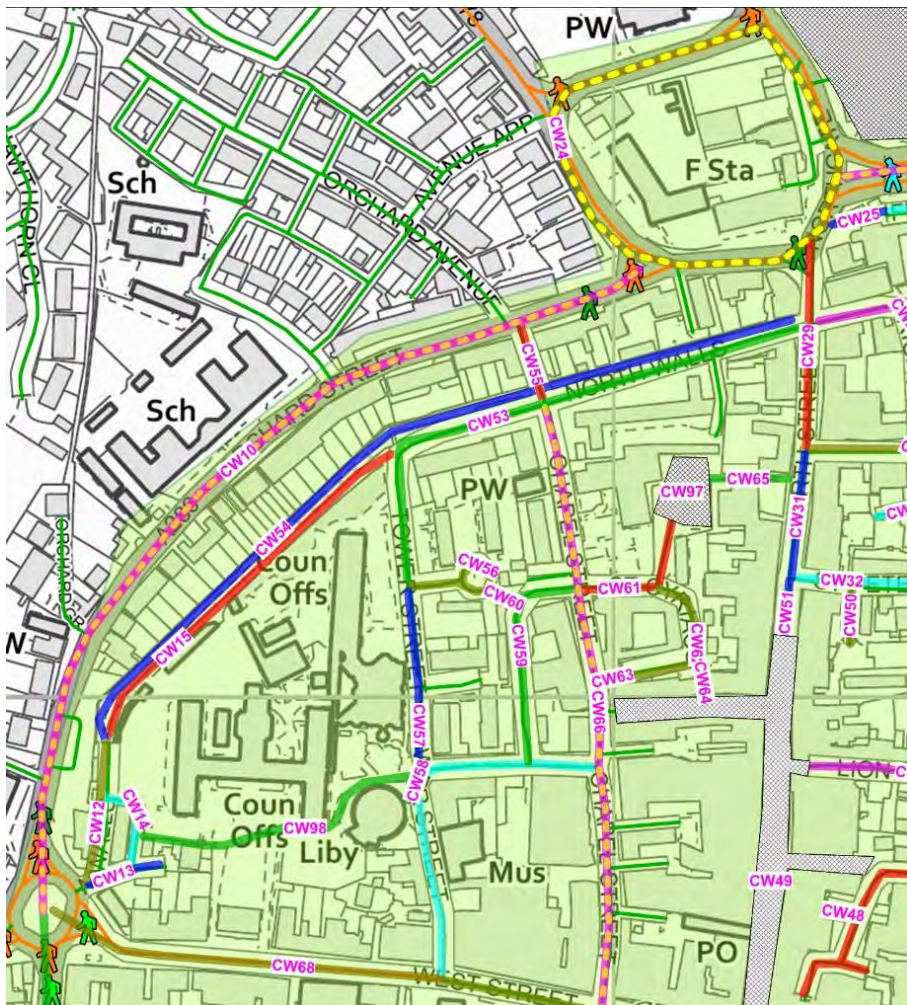
Plan 16. North west area

- **CW66** Chapel Street where the crossings of side streets are consistently sited away from junctions where visibility was compromised.
- **CW10** Orchard Street has heavy traffic very close to pedestrians.
- **CW24** Northgate gyratory fails on all three safety categories, with proximity to heavy and fast moving traffic and some visibility issues at crossings.

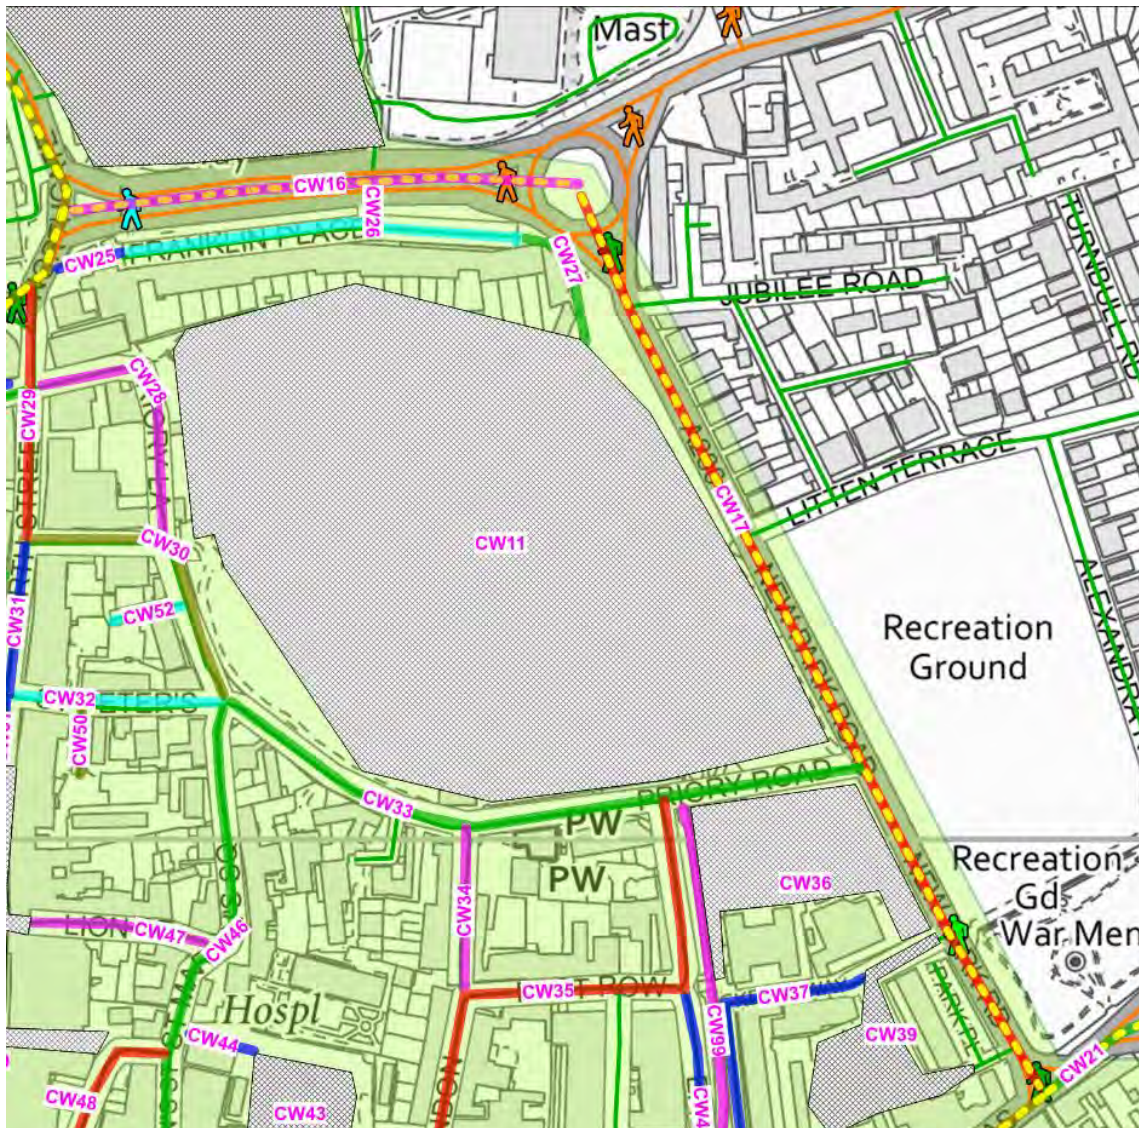
Plan 17. North east area

- **CW16** Oaklands Way has pedestrian proximity to heavy traffic.
- **CW17** New Park Road has close pedestrian proximity to heavy and fast moving traffic.

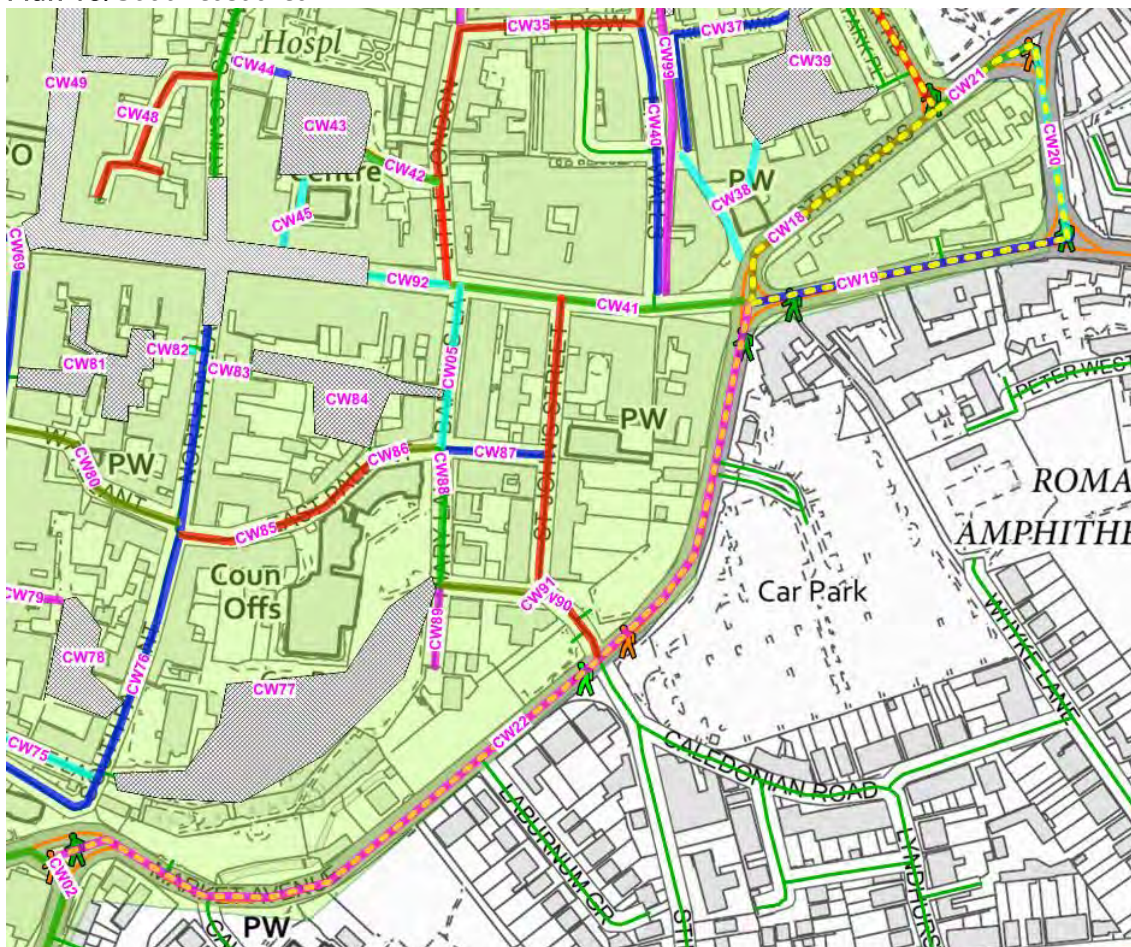
Plan 18. South east area

- **CW22** Market Road has fast moving traffic.
- **CW18** St Pancras, **CW19** The Hornet and **CW20** Needlemakers has heavy fast moving traffic in close proximity to pedestrians
- **CW21** St Pancras failed on all three safety categories, with proximity to heavy and fast moving traffic and some visibility issues at crossings.

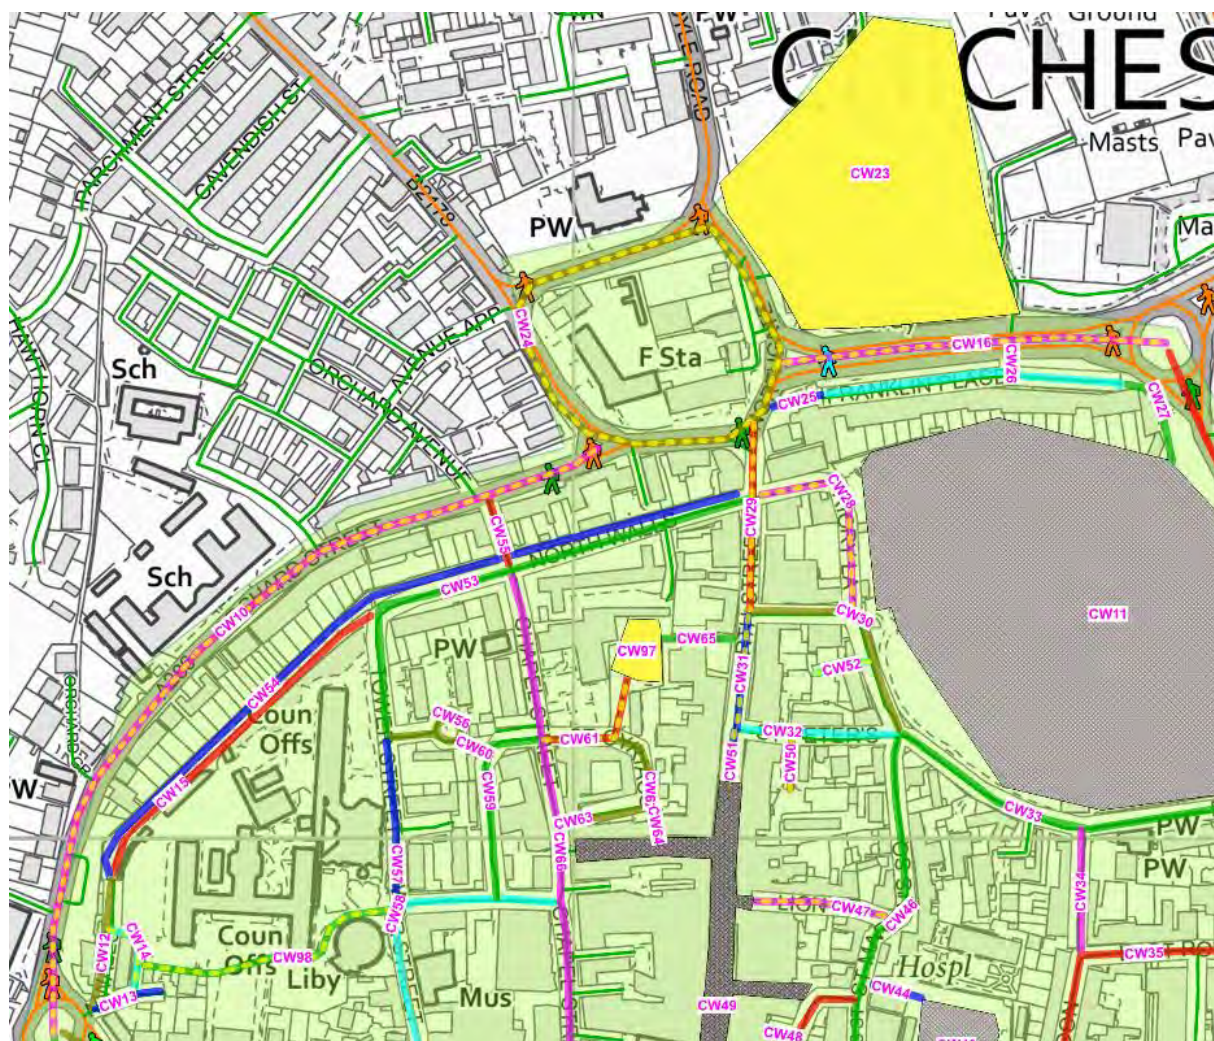
Plan 19. North area

- **CW10** Orchard Street
- **CW14** West Sussex County Council access road
- **CW16** Oaklands Way
- **CW23** Theatre car park
- **CW24** Northgate gyratory
- **CW28** Priory Lane
- **CW29** and **CW31** North Street
- **CW47** Lion Street
- **CW50** St Peters

- **CW51** North Street
- **CW60** Path - Tower Close to The Providence
- **CW61** St Cypriacs
- **CW97** St Cypriacs car park
- **CW98** West Sussex County Council buildings

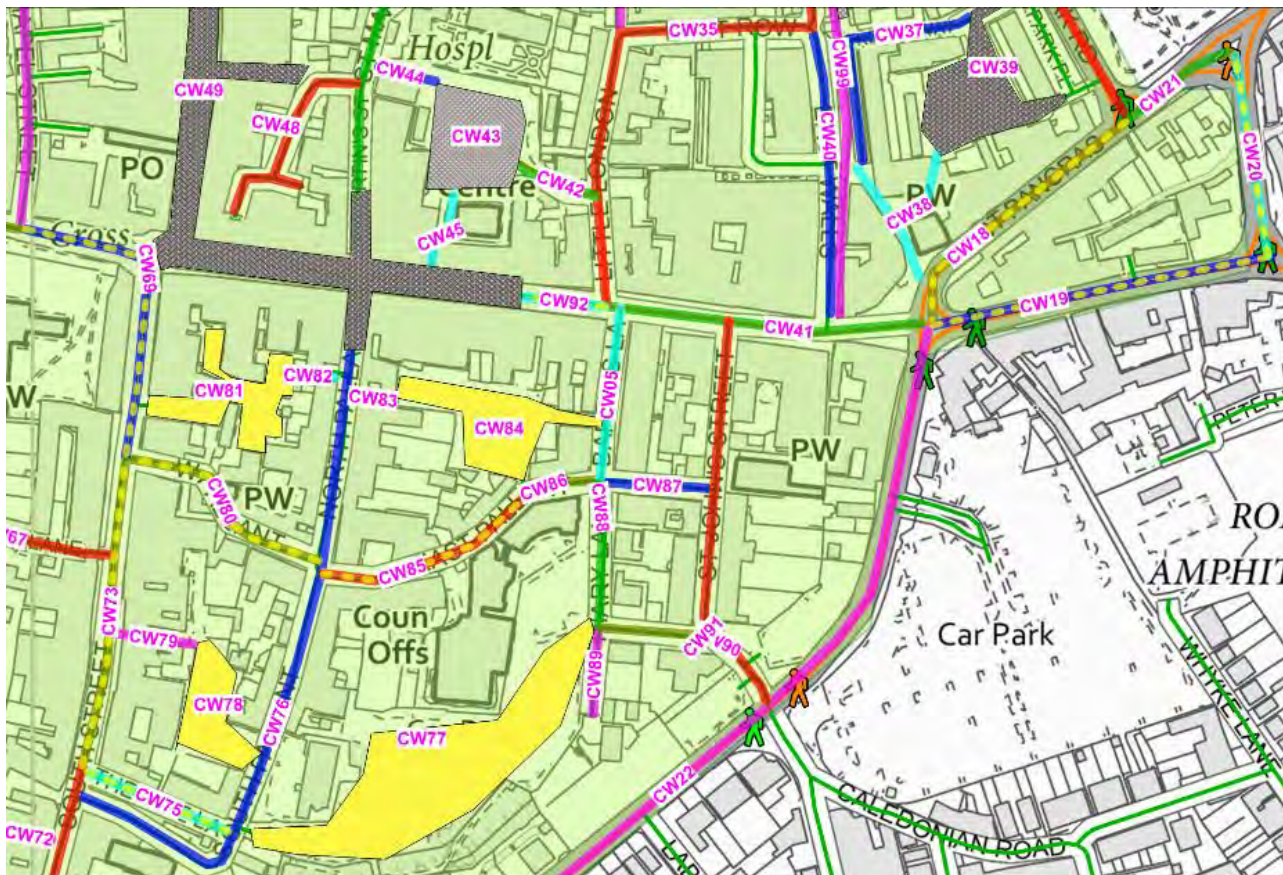
Plan 20. South east area

- **CW18** St Pancras
- **CW19** The Hornet
- **CW20** Needlemakers
- **CW69** West Street & South Street
- **CW73** South Street
- **CW75** Theatre Lane
- **CW77** Cawley Priory car park
- **CW78** South Pallant car park
- **CW80** West Pallant
- **CW81** Cooper Street car park
- **CW84** Baffins Lane car park
- **CW85** East Pallant
- **CW92** East Street

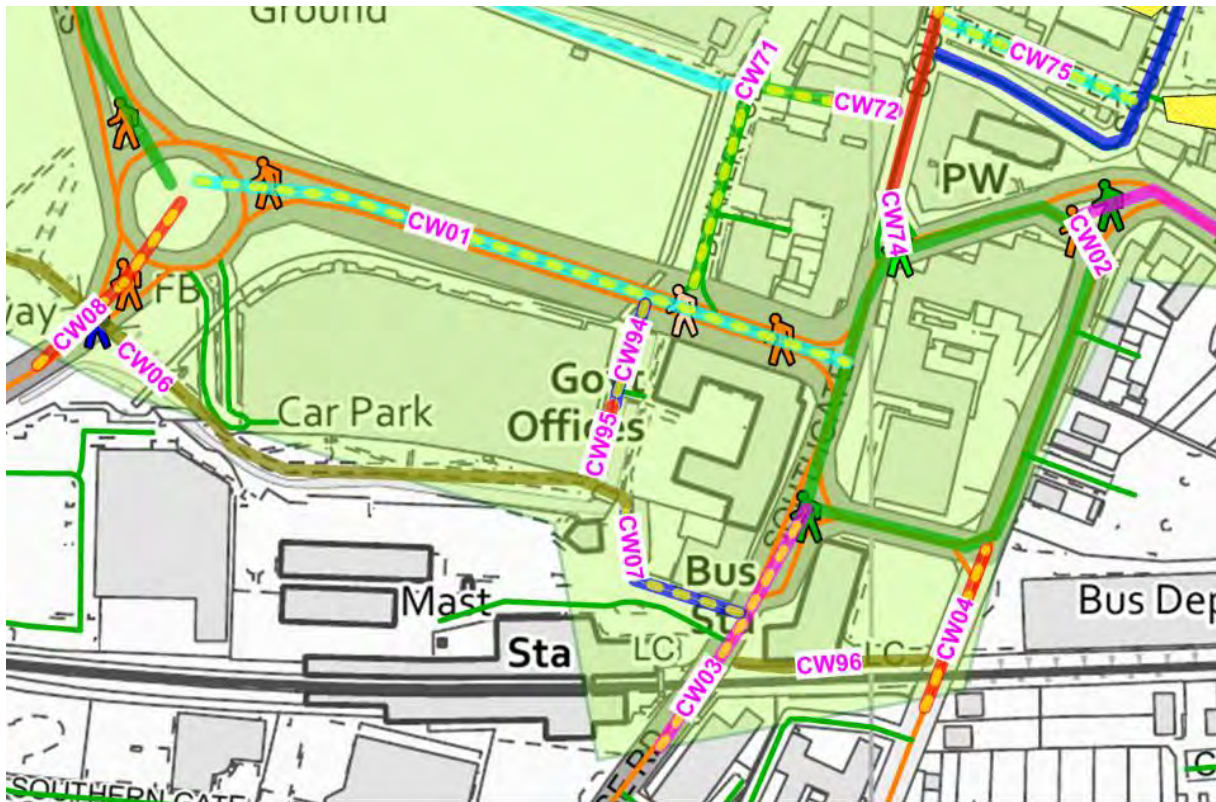
Plan 21. South west area

- **CW01** Avenue de Chartres
- **CW03** Southgate and Stockbridge Road
- **CW04** Basin Road
- **CW07** Station Approach
- **CW08** Via Ravenna
- **CW73** South Street
- **CW94** Access by multi-storey car park
