Chichester City LCWIP

Appendix C

Walking audit – Core Walking Zone & key routes

June 2020

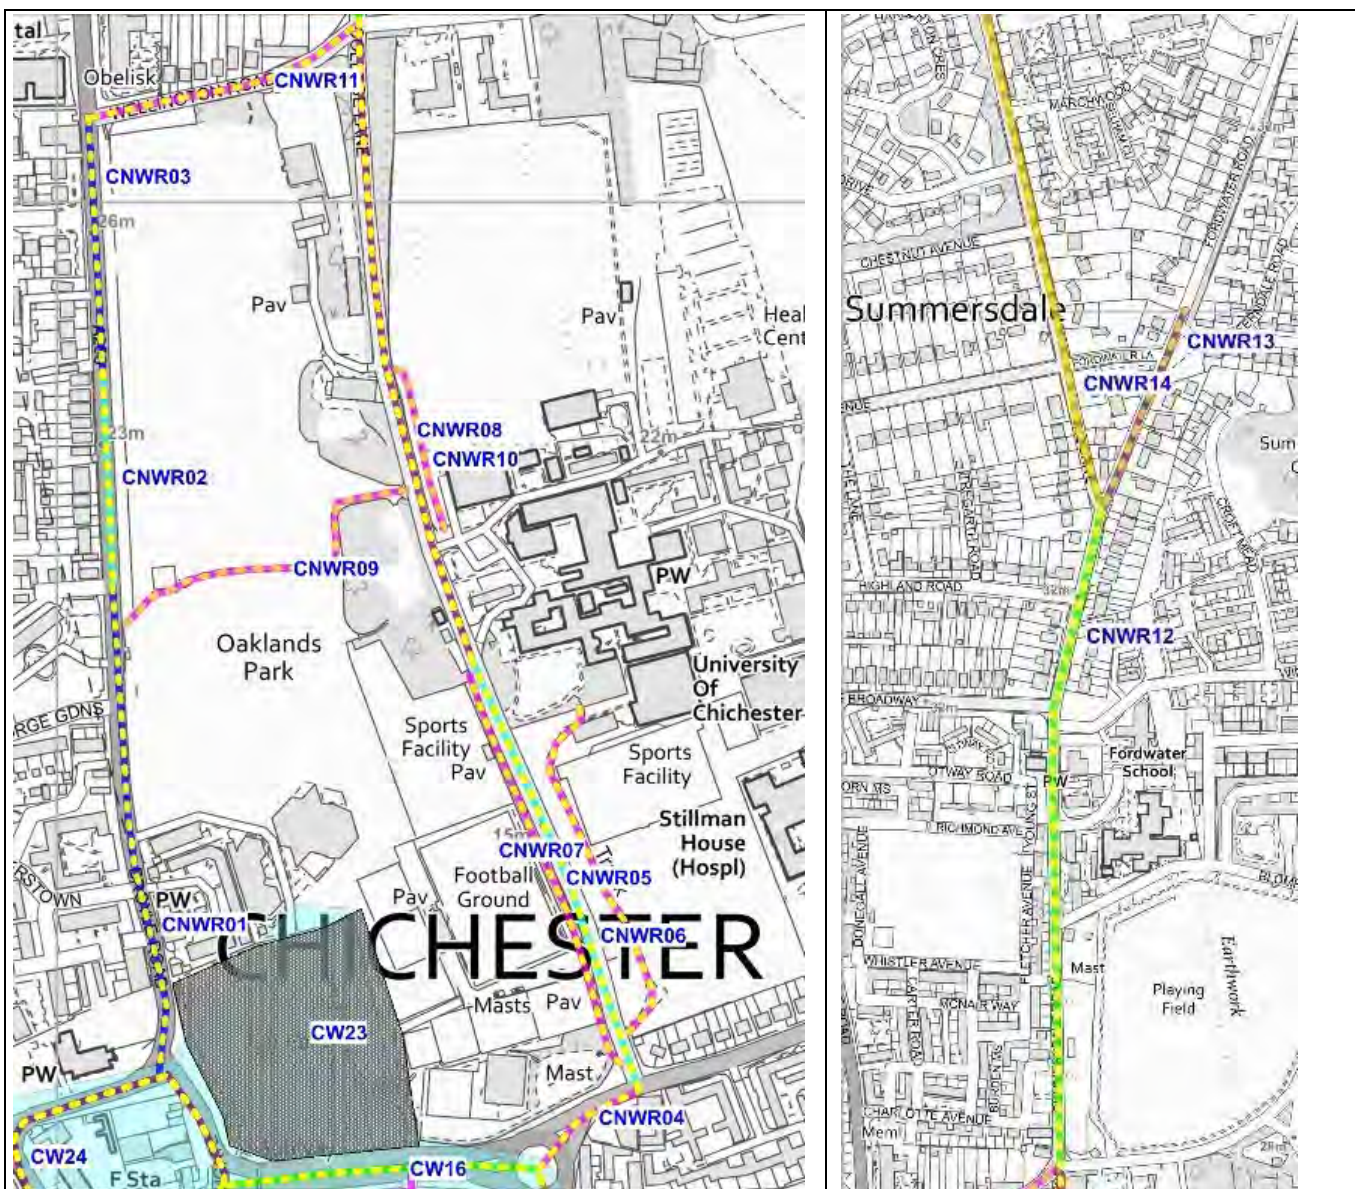
Plan 22 Northern route

The northern route was split into 14 separate sections which are shown on the two plans to the left and right. All these sections are dotted yellow in the plans, indicating that they all failed at least one of the twenty assessment criteria.

The key section is the routing along College Lane between Spitalfield Lane and Wellington Road and particularly the southern section of this from the entrance to the University. This latter is served by

three possible approaches. However, one of these **CNWR07**, the path to the east of College Lane, only gives limited access to the south of the University.

College Lane itself is narrow with a footpath on the east side only. The footpath is very narrow and its condition is very poor. While the road is not heavily trafficked what traffic there is tends pass at speed due partly to being on a gradient and the overall tunnel effect is further exacerbated by walls and then trees along both sides. The environment feels very hostile for pedestrians in daylight hours.

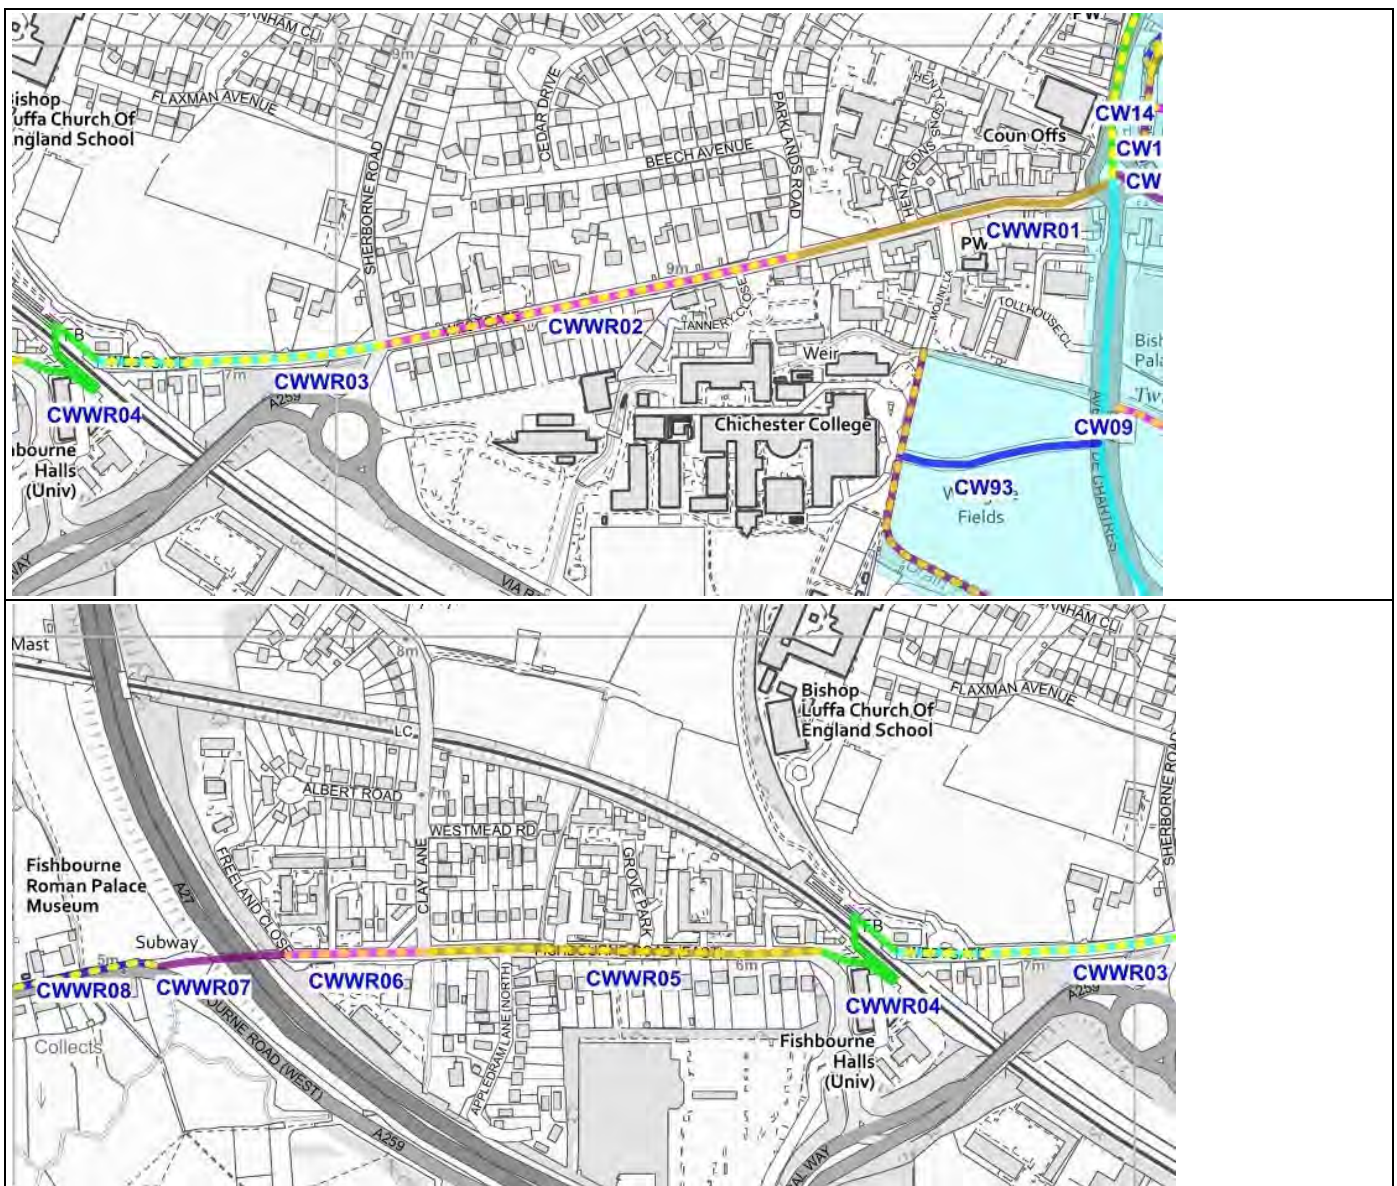
Plan 23 Western route

The eight sections of the western route are shown in the plan above. Those that failed any of the twenty assessment criteria are dotted yellow. Unlike the northern route there were three sections that did not fail any of the criteria.

Four of the five sections that failed did so for coherence. This is primarily an absence of tactile paving and/or dropped kerbs at key desire crossing points. While we would expect all crossings of junctions and busier private accesses to have tactile paving, the provision at older minor accesses is often mixed. For the sections assessed here the presence of tactile paving was generally not coherent, with some minor crossings having tactile paving and some major ones lacking it. This is worse than having nothing at all as visually impaired people might then have a false sense of security.

- **CWWR02** Westgate – failed for coherence and more crucially for the lack of crossing provision at its west end at the junction with Sherborne Road. This is a fairly busy roundabout where pedestrians on the south of Westgate must cross to the north as there is no footpath on the south side of Westgate west of the junction. This is wholly unsatisfactory for the most serious at grade crossing on the whole route.

- **CWWR03** Westgate – failed for the same reason of the crossing of its eastern junction, and coherence. The issues are even more severe on this side of the junction with missing crossing points and the disappearing footpath. Also at peak hours, traffic queues across the junction increasing the perceived hazard.

- **CWWR05 & CWWR06** Fishbourne Road East – both failed for issues of coherence and inconsistency in provision of tactile paving. Junctions also had wide swept curve accesses no matter how minor.

- **CWWR08** Fishbourne Road West – failed for some very poor surfacing and the total absence of any crossing from its south to north side on this section.

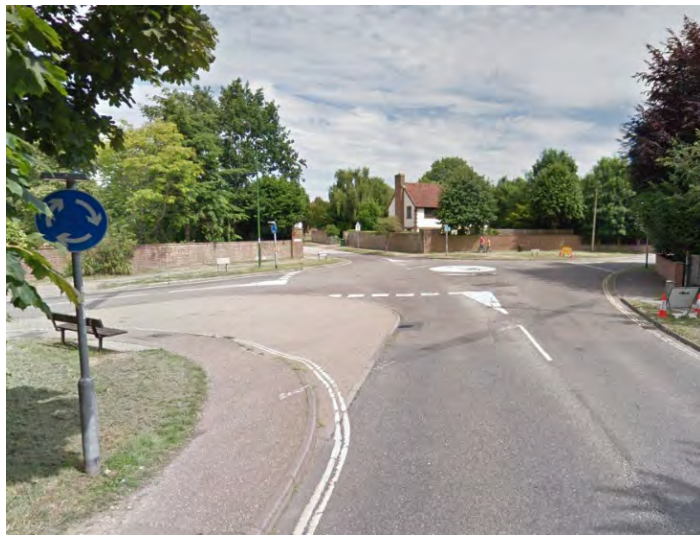
Junction of Westgate / Sherborne Road, from the south - traffic can back onto this from the south at peak times

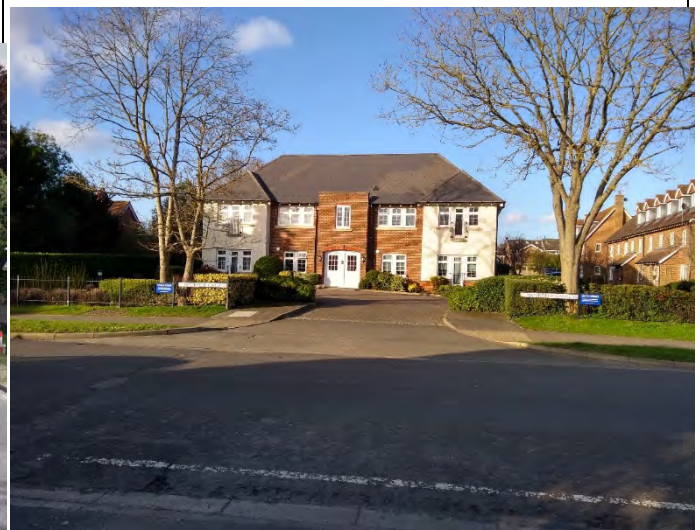
Typical junction splay for a private residential access - much too large for this location
