Chichester City LCWIP

Appendix C

Walking audit – Core Walking Zone & key routes

June 2020

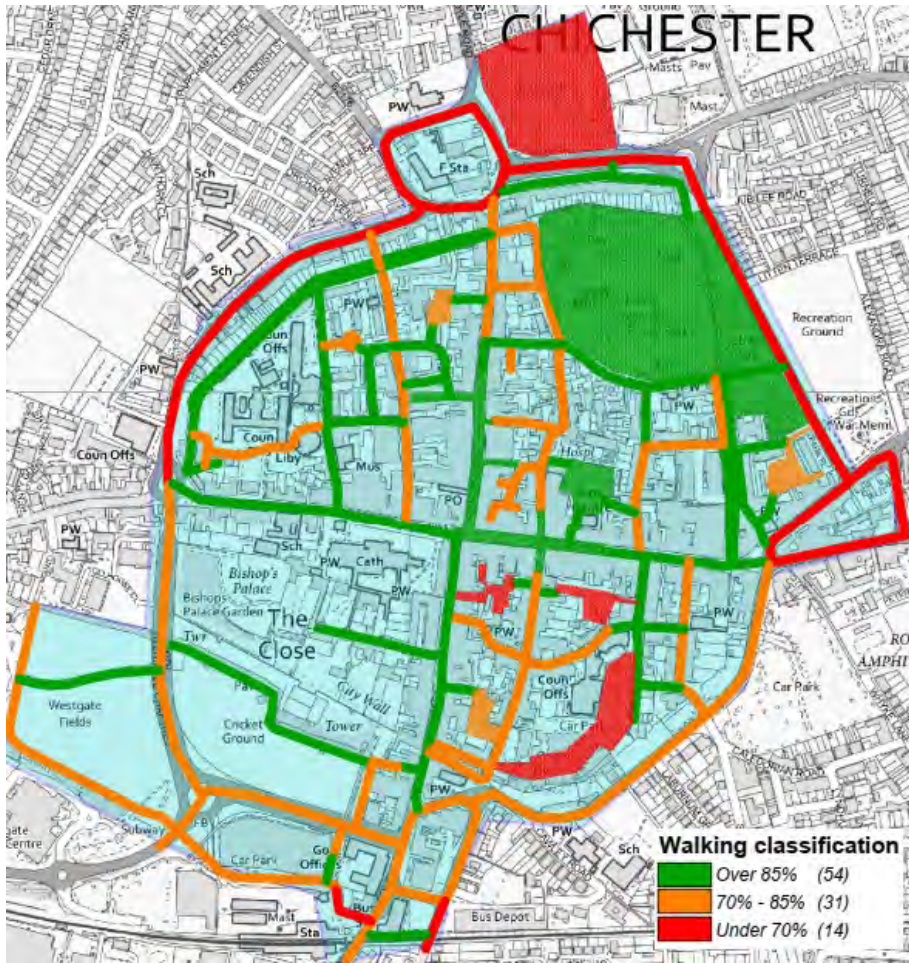
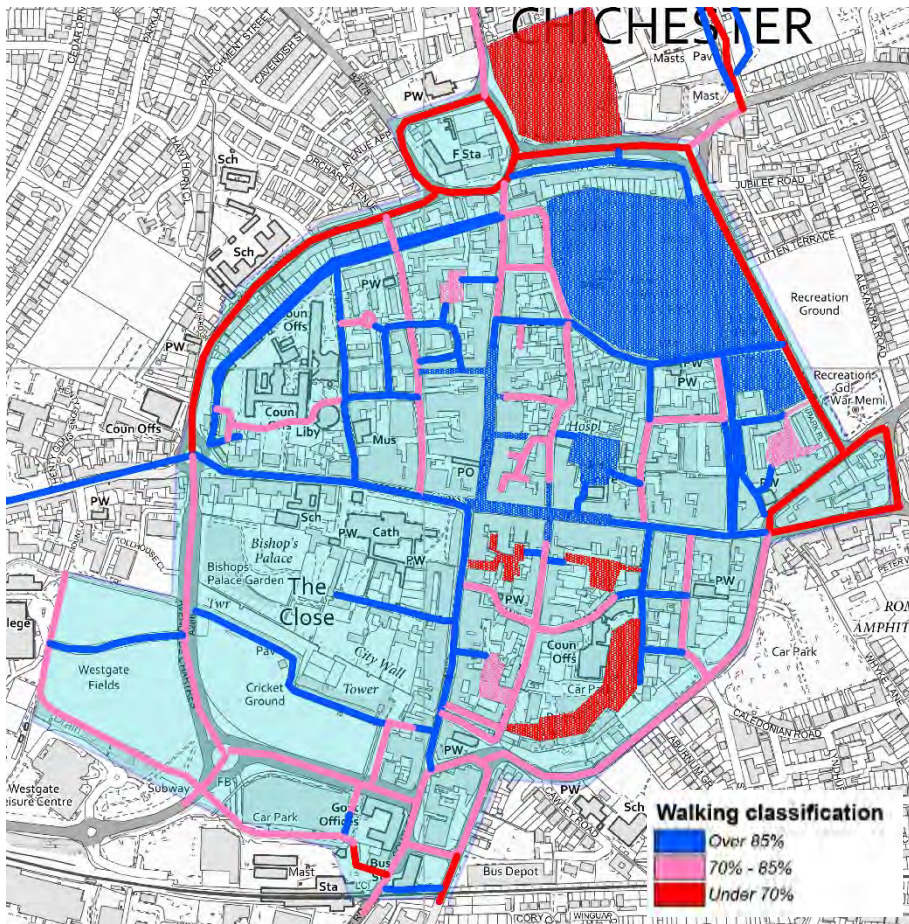
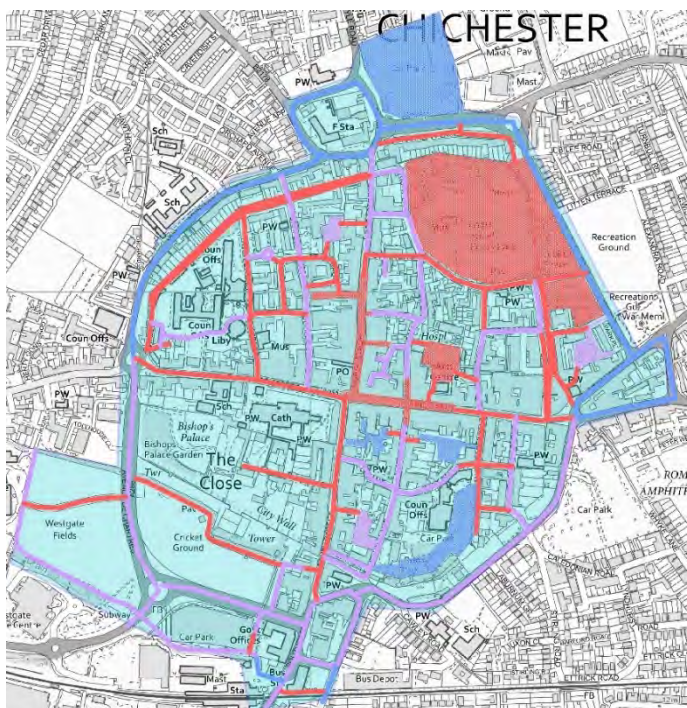
Plan 3. Audit links and areas classified by % score (with alternate version for colour blindness)

Overall, 54 links or areas were classified as Good, with 31 Adequate (i.e. improvements would be of some benefit) and 14 Poor. The latter are listed below.
